Extension of the operational lifetime
of the proportional chambers
in the HERMES spectrometer

大西研論文ゼミ 2024/10/30

木村佑斗

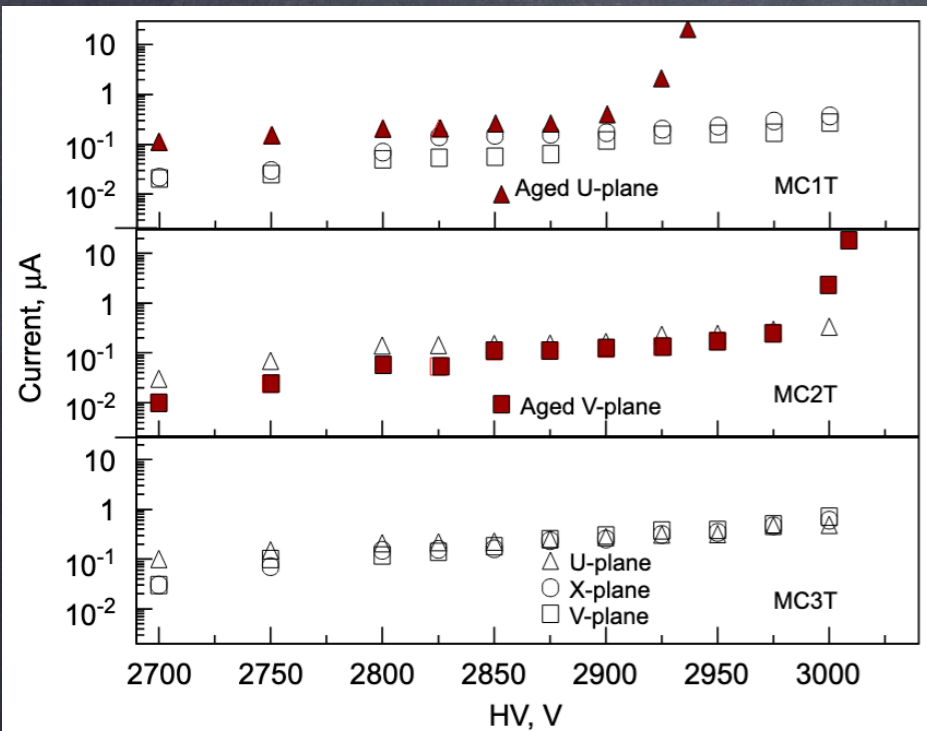
Fig. 2. Dependence of the beam ionisation current from the high voltage for the top chambers. Sustained current appears in the MC1 U-plane and MC2 V-plane top block chambers at HV = 2925 and 3000 V correspondingly.

Sustained currents
on cathode wires

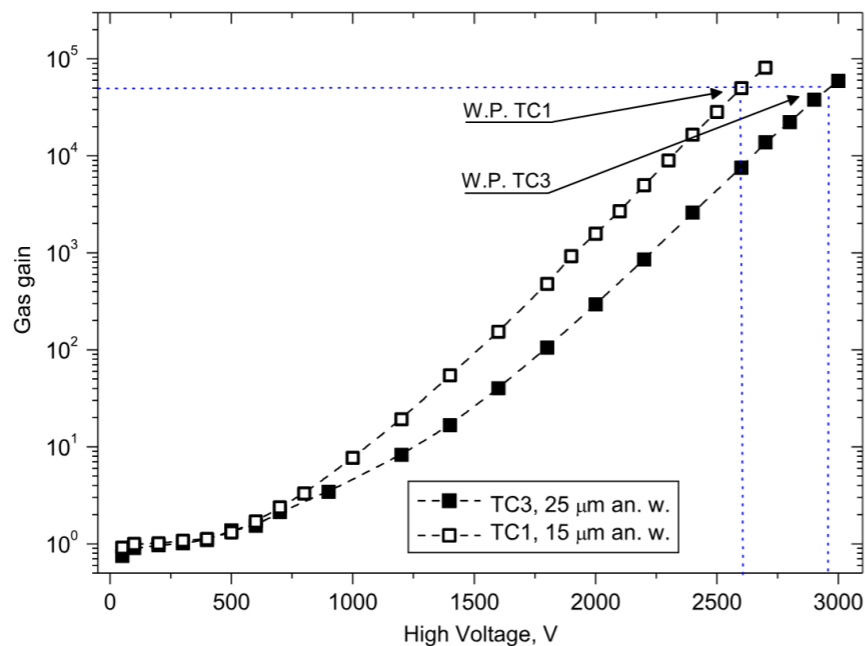
Fig. 4. Gas gain dependence on the high voltage for the test chambers TC1 with anode wire diameter 15 μ m and TC3 with anode wire diameter 25 μ m.

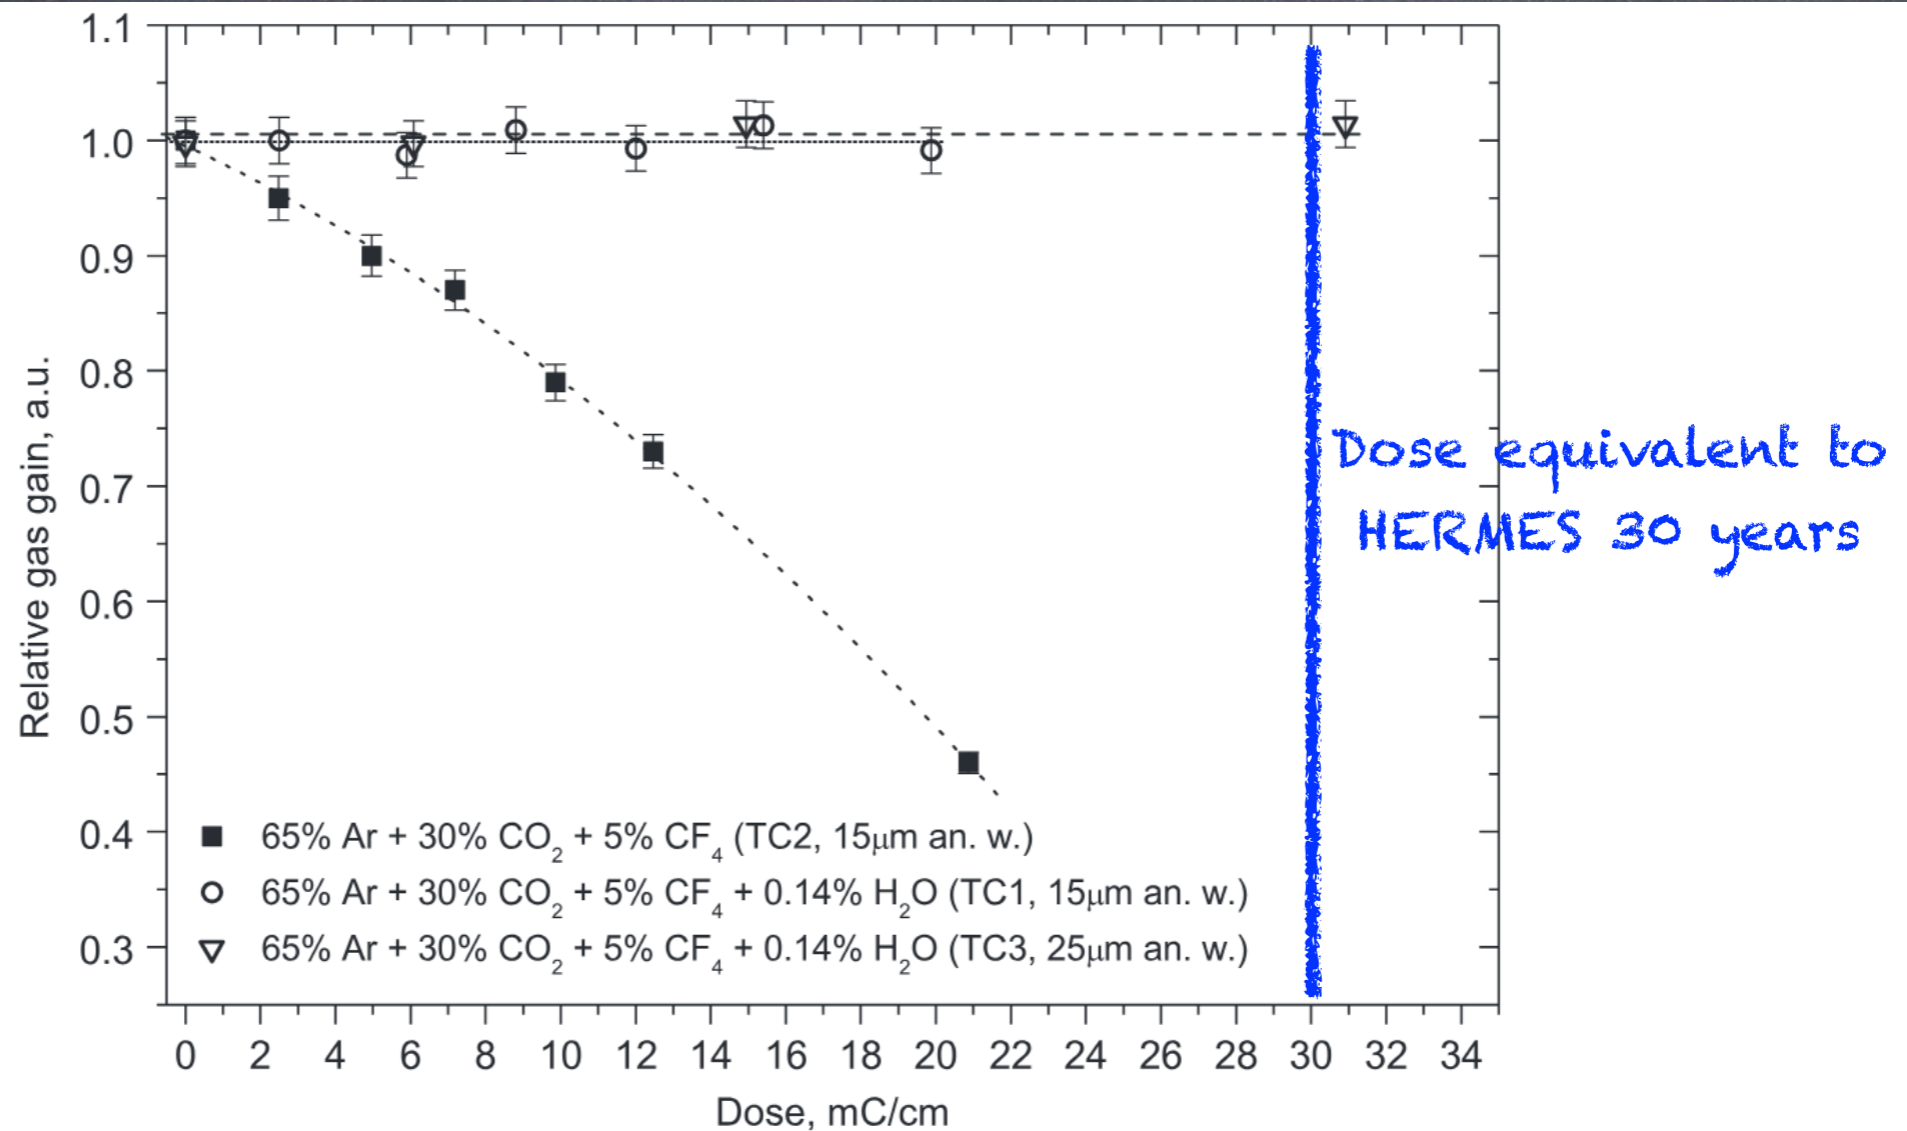
Fig. 5. Dependence of the relative gain in the irradiated zone versus accumulated charge by the anode wires. Black squares correspond to the test with standard MCs gas mixture. White cycles and triangles correspond to the test of both types of proportional chambers with addition of 0.14% H₂O to the standard gas mixture.

Stability of gas gain due to adding water

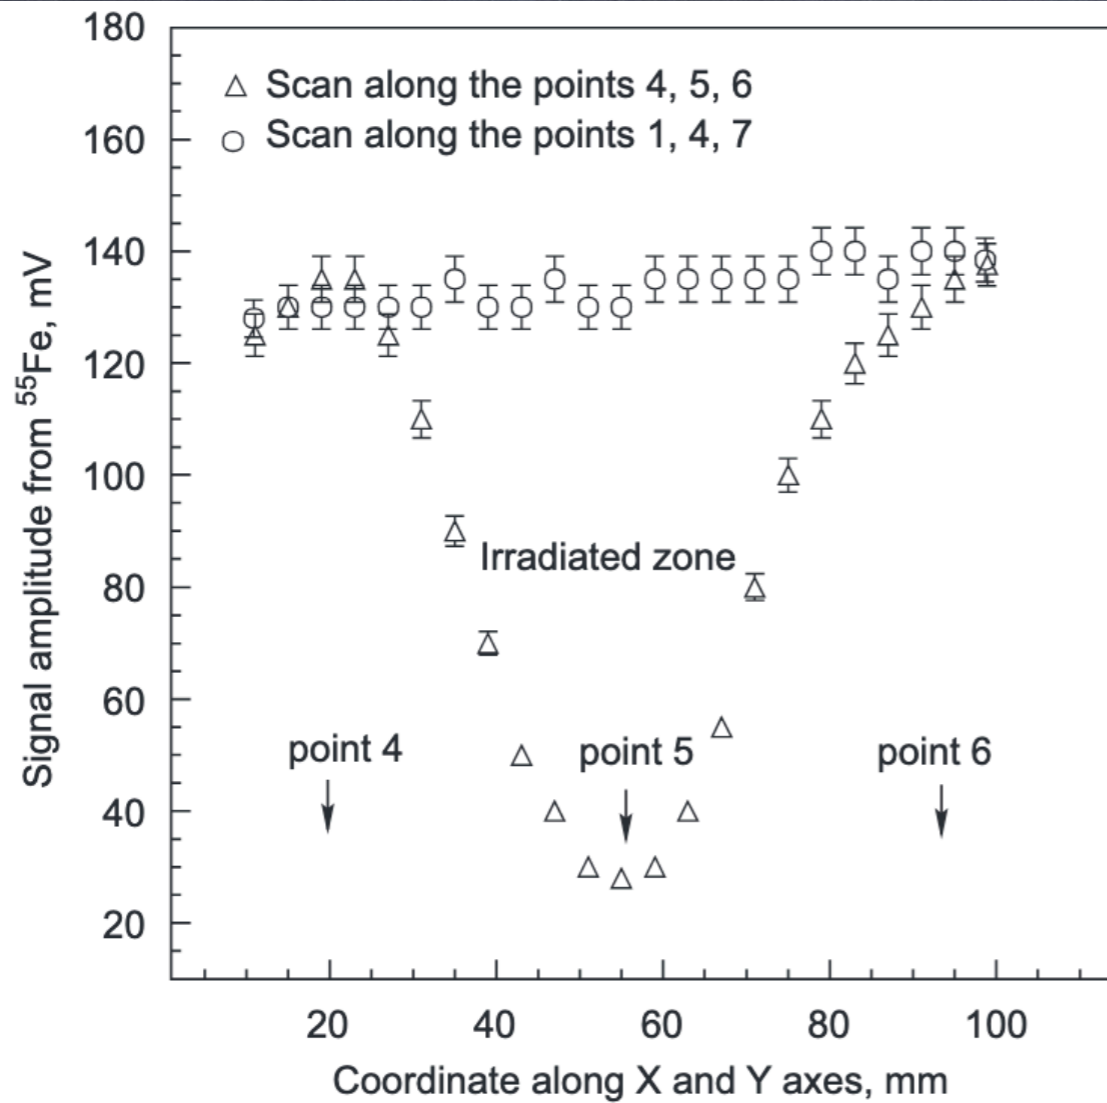
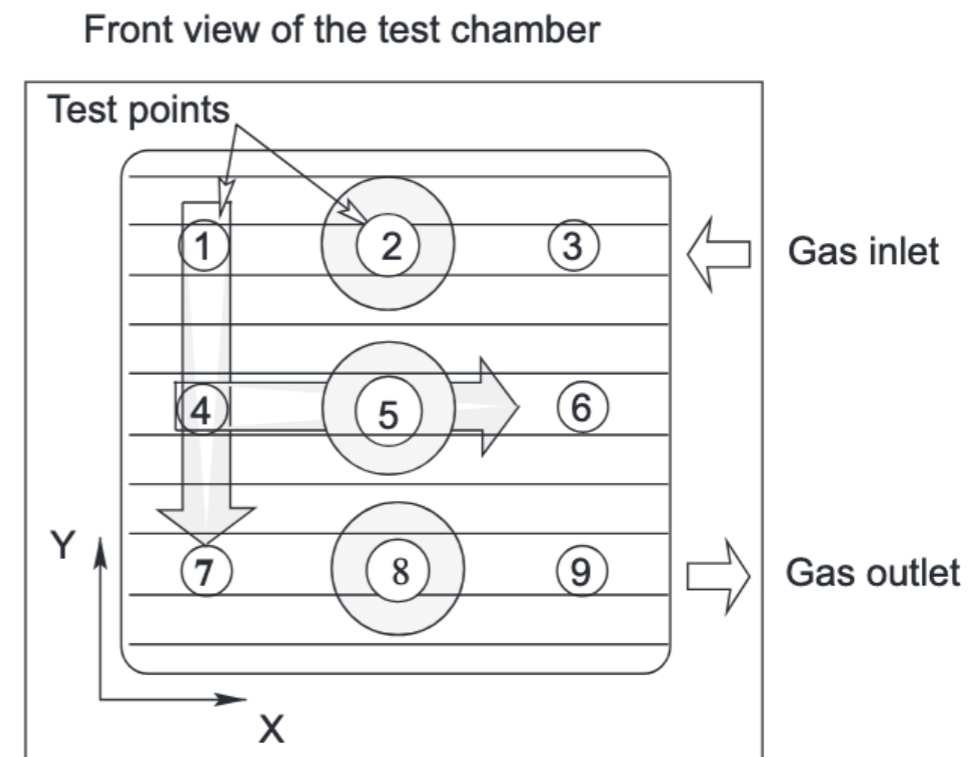
Fig. 6. The amplitude scans with an ^{55}Fe γ -source along the Y-axis through non-irradiated points 1, 4, 7 and along the X-axis through one of the irradiated zones in the point 5. The anode wires are shown in a front view of the test chamber by the lines directed along the X-axis. The accumulated charge in the irradiated zone at point 5 is equal to $Q_{\text{anode}}^{\text{point 5}} = 32 \text{ mC/cm}$.

Aging effect on anode wire appeared only in irradiation area.

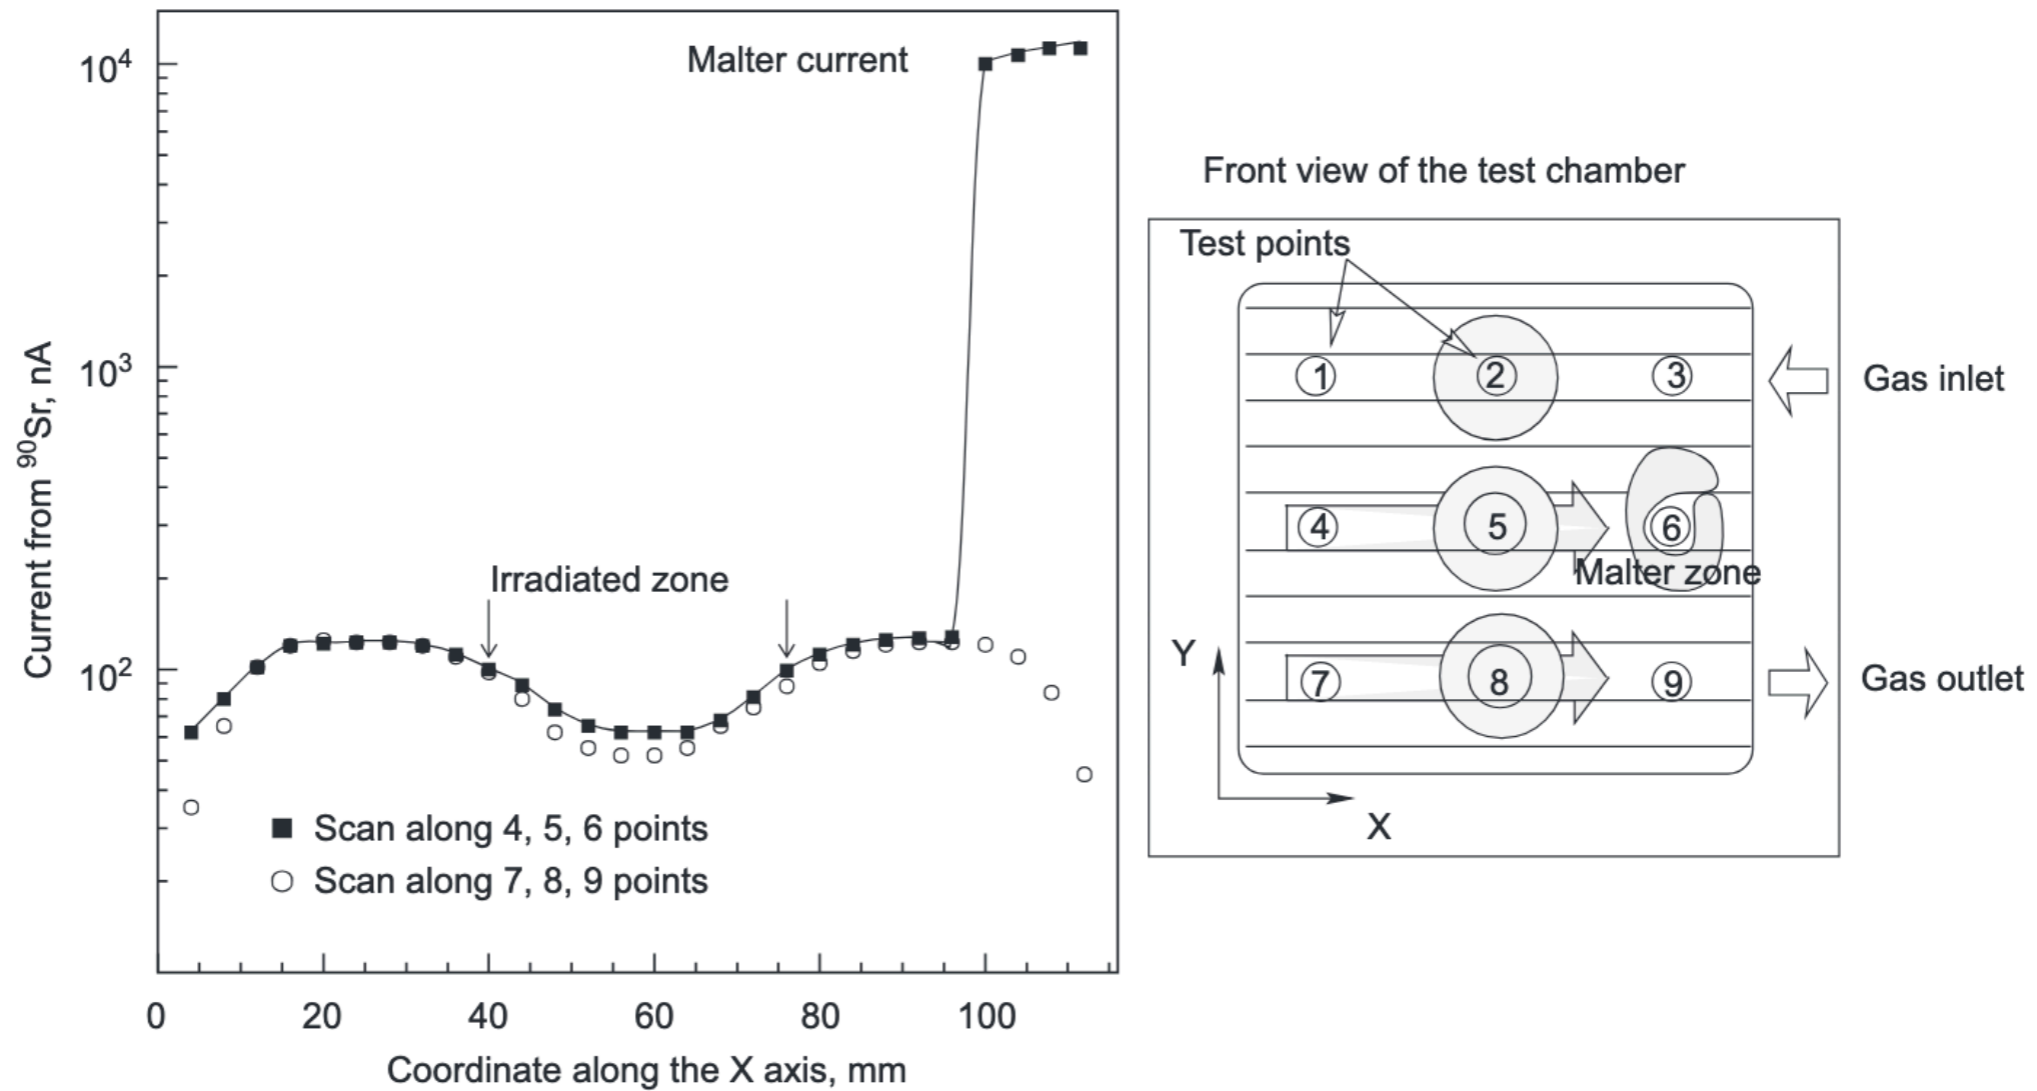
Fig. 7. Scans by the collimated ^{90}Sr β -source along the anode wires. The total accumulated charge in the irradiated zones 2, 5 and 8 is $Q_{anode}^{test} = 95 \text{ mC/cm}$ that corresponds to $Q_{cathode} = 4.75 \text{ mC/cm}$ for the cathode wires. An area where the ^{90}Sr ignited the self-sustained current is marked as 'Malter zone'.

Cathode aging appeared at accumulated charge of $Q_{cathode} = 4.75 \text{ mC/cm}$.

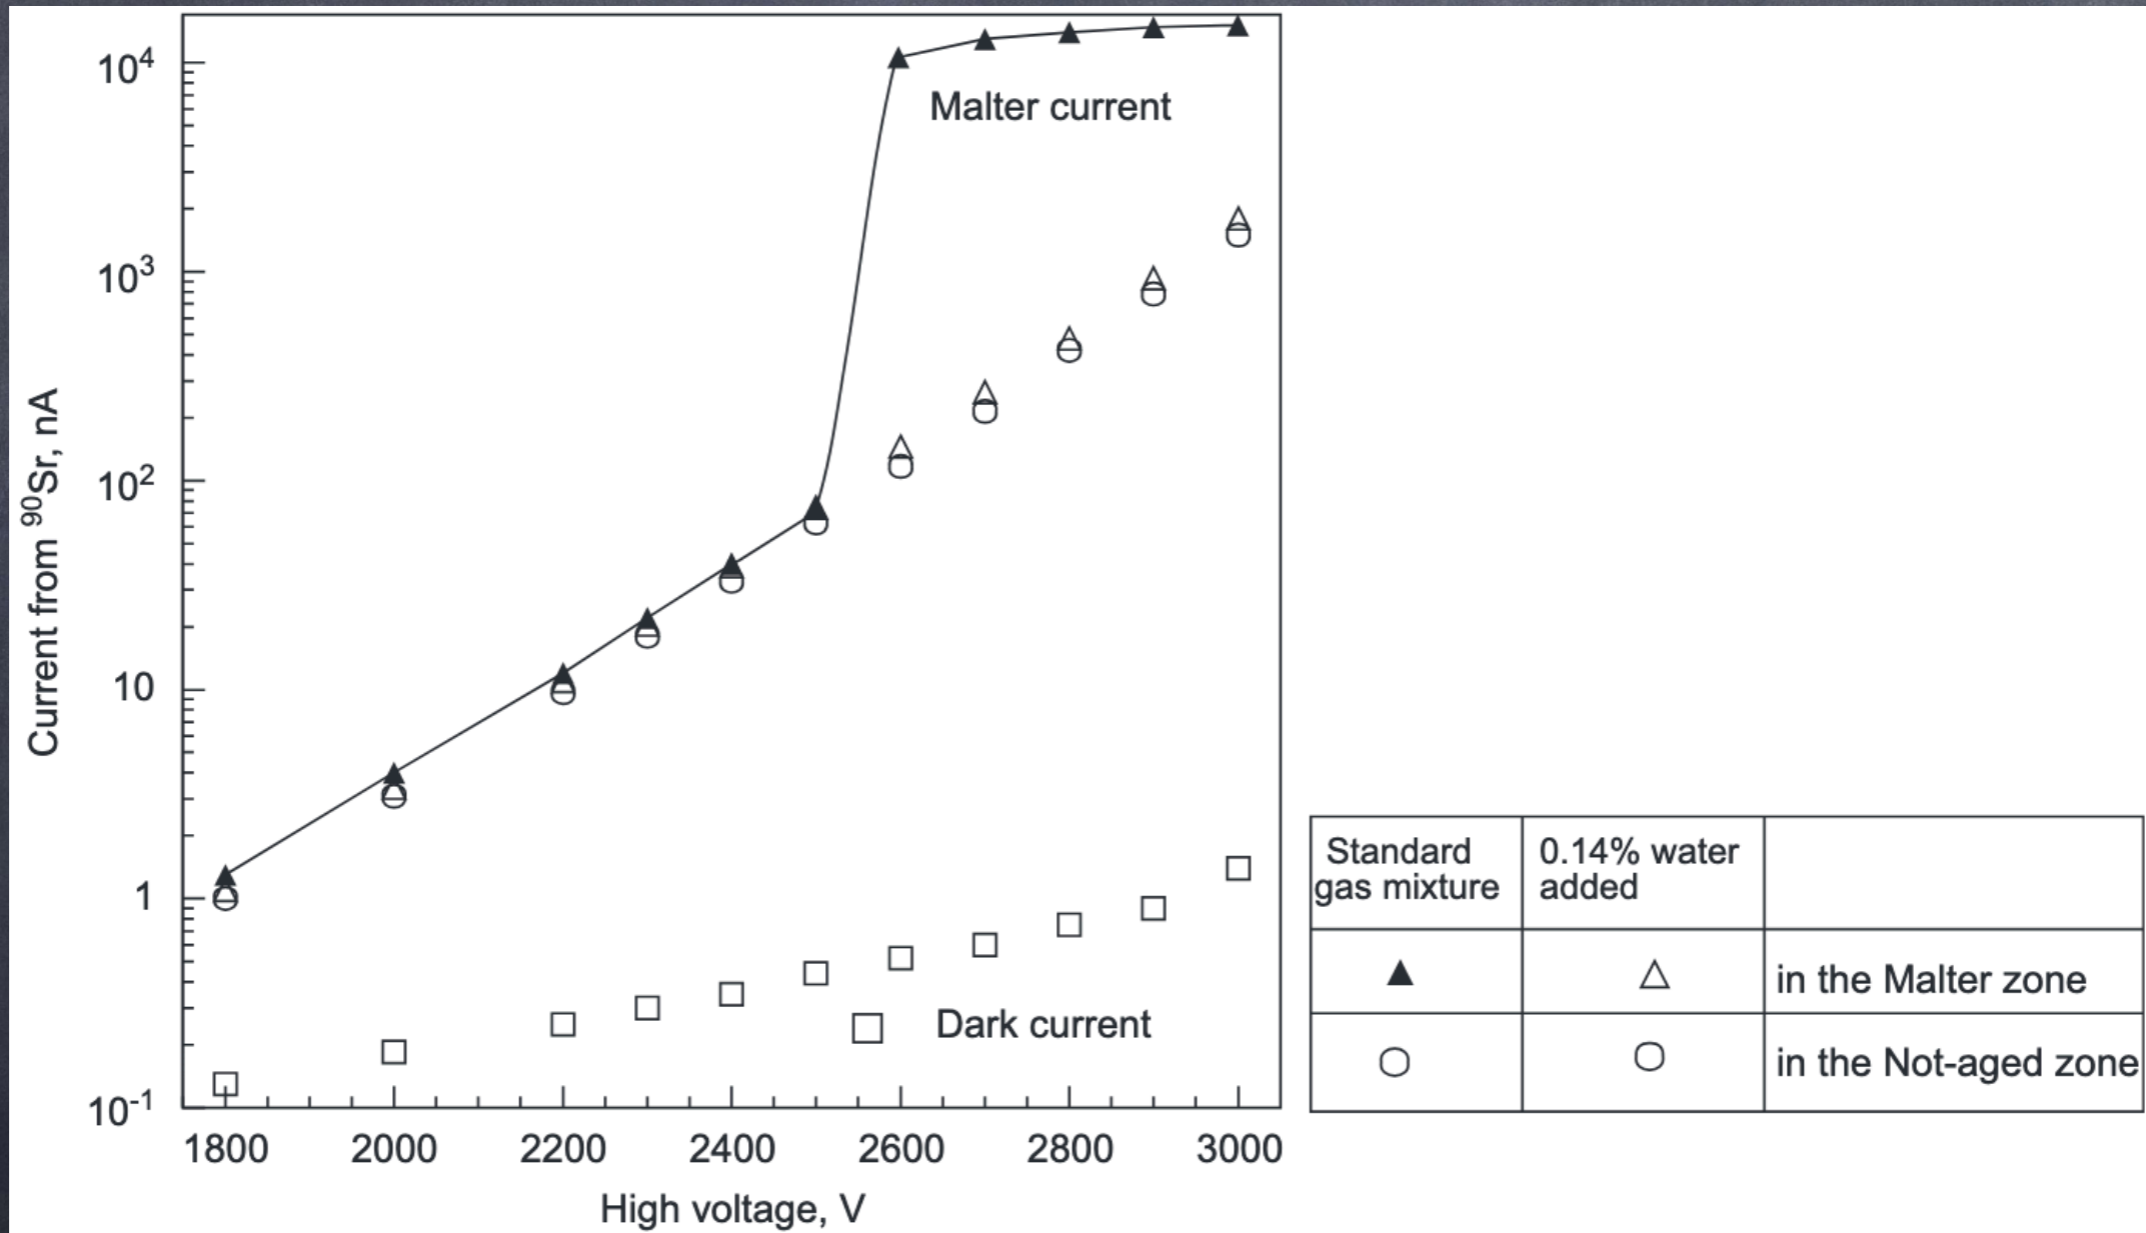
Fig. 8. Dependence of the ^{90}Sr ionisation current and dark current from high voltage.

Water can prevent the Malter Effect.

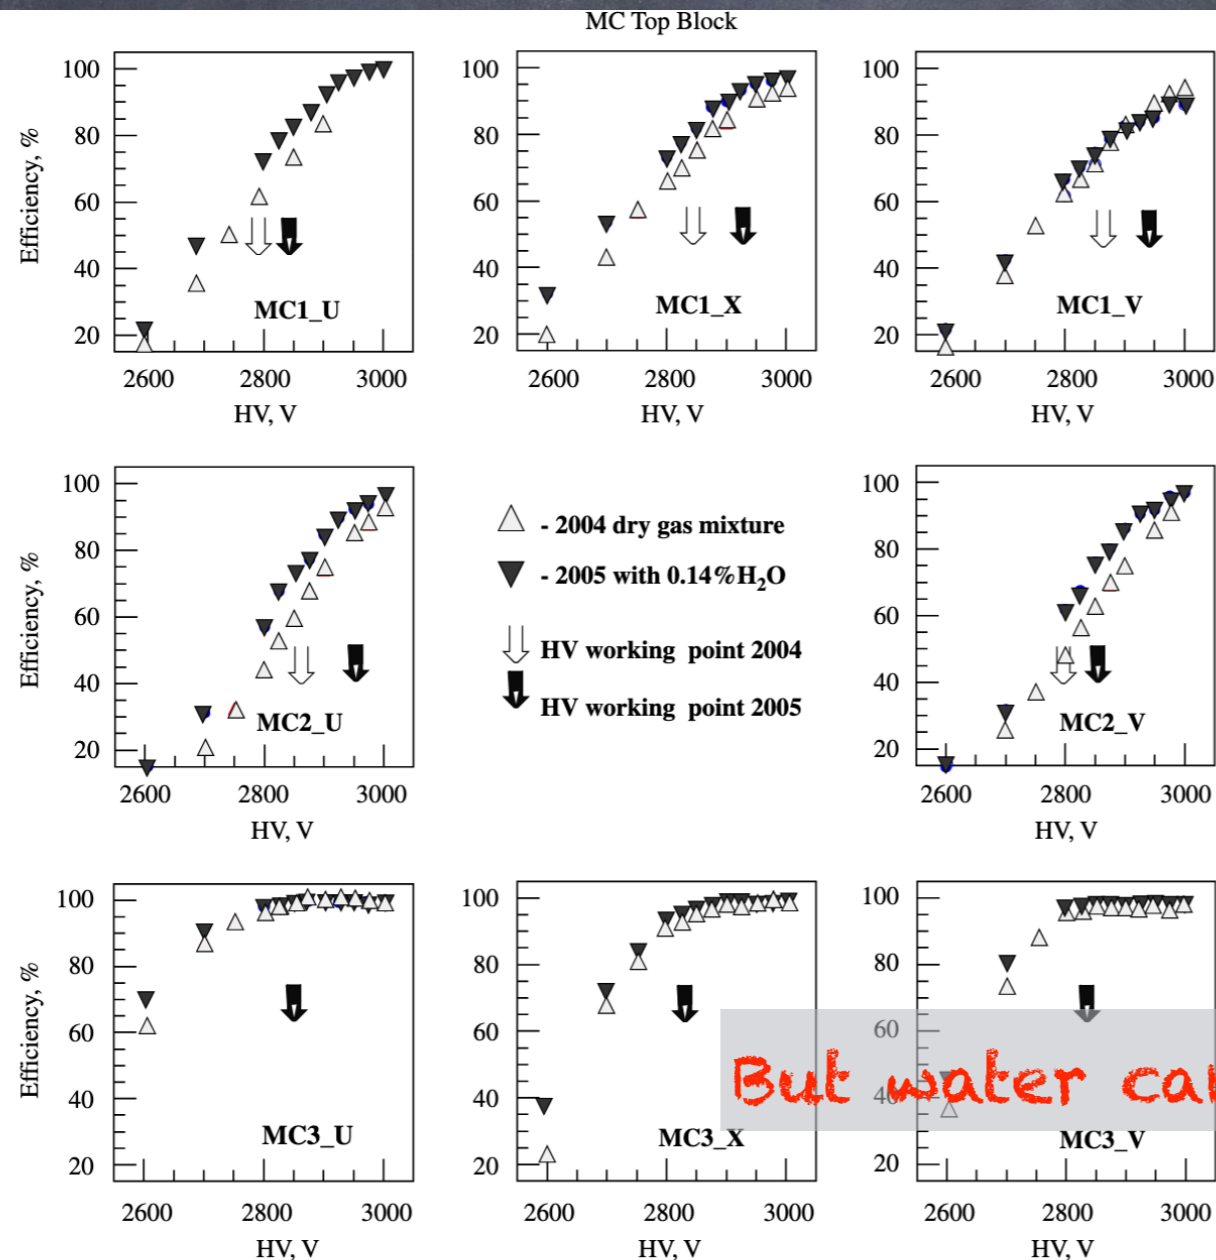
Fig. 10. Magnet chambers efficiency for the top block chamber versus high voltage at standard threshold used for data taken in the HERA positron beam. First measurement with dry gas mixture (▼) and next after adding of 0.14% H₂O (▲).

- Water was added since 2005.
- High Voltage scan in the electron beam → **no matter current** up to 3,000 V
- Higher efficiency due to water which disactivates the screening effect around cathode

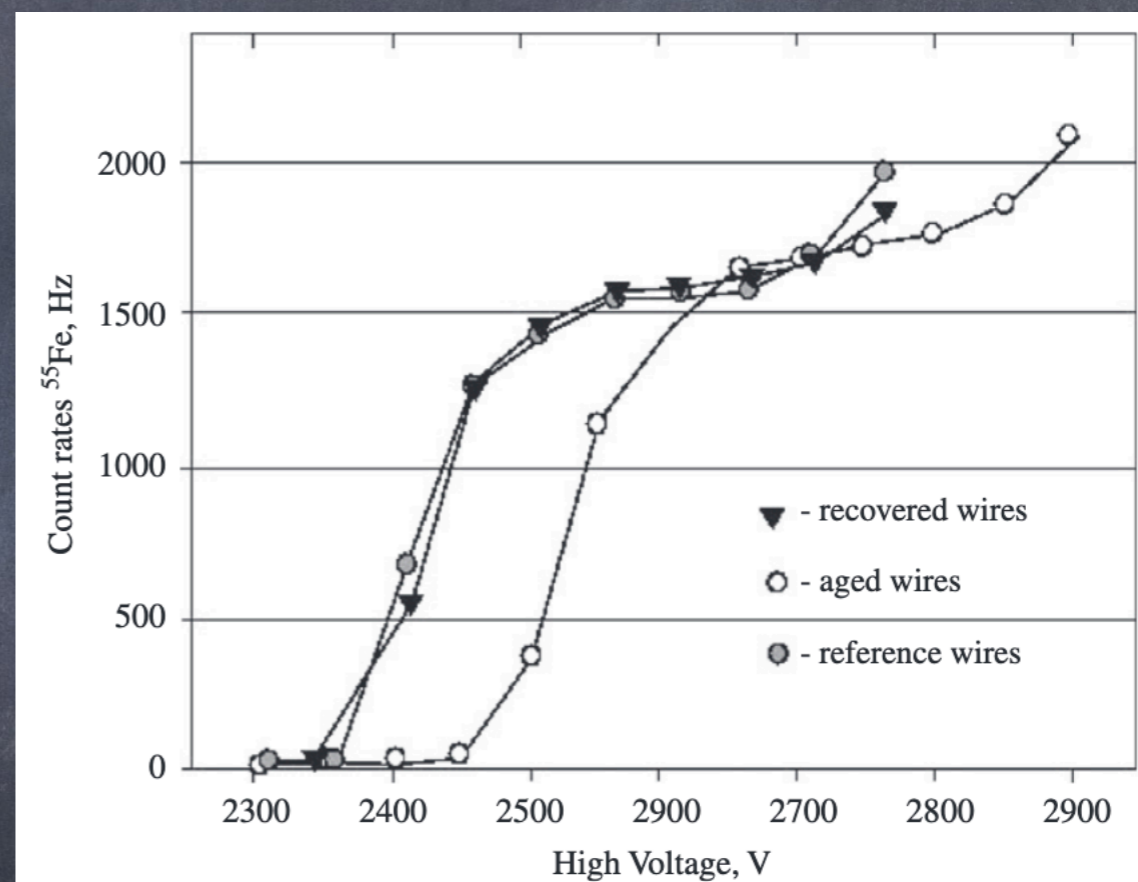
Fig. 17. Count rates from ⁵⁵Fe γ -ray source measured after aging and recovery procedure as a comparison with the count rate from the reference non-irradiated zone.
